Subject: Johnson and Wales College

Re: Johnson & Wales College Dormitory
203 Weybosset Street

BUILDING INSPECTED UNDER RHODE ISLAND FIRE SAFETY CODE CHAPTER 23-20

SUBJECT: Fire Code Violations
Johnson and Wales College
Crown Hall
208 Weybosset St.

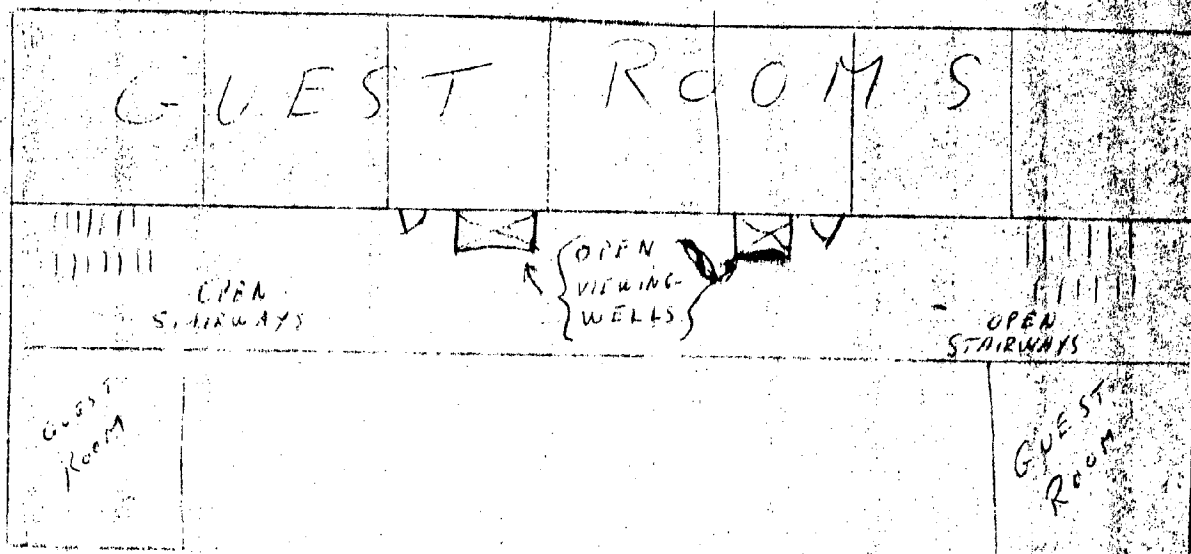
DIAGRAM #1

TYPICAL FLOOR PLAN (FLOORS 2-8)

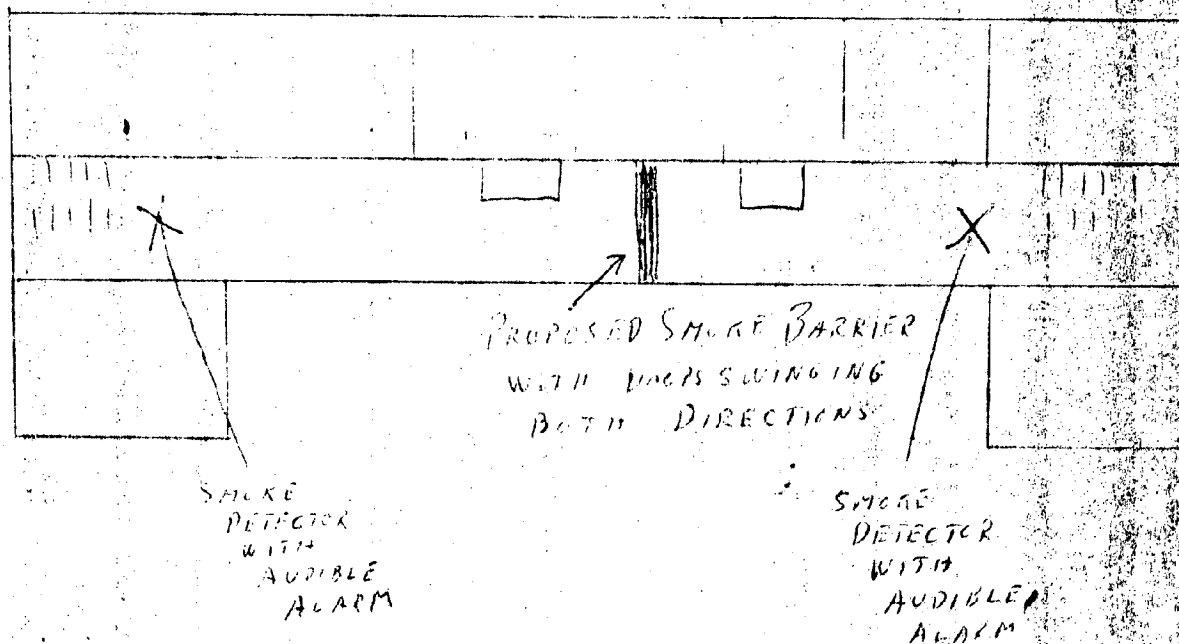
DIAGRAM #2

PROPOSED IMPROVEMENTS
