**PROVIDENCE  
COMMUNITY  
RENEWAL  
PROGRAM  
1964 - 1970**

**TECHNICAL SUPPLEMENT**

**APPENDIX D·E·F·G**

**BLAIR ASSOCIATES • PLANNERS • PROVIDENCE • RHODE ISLAND**

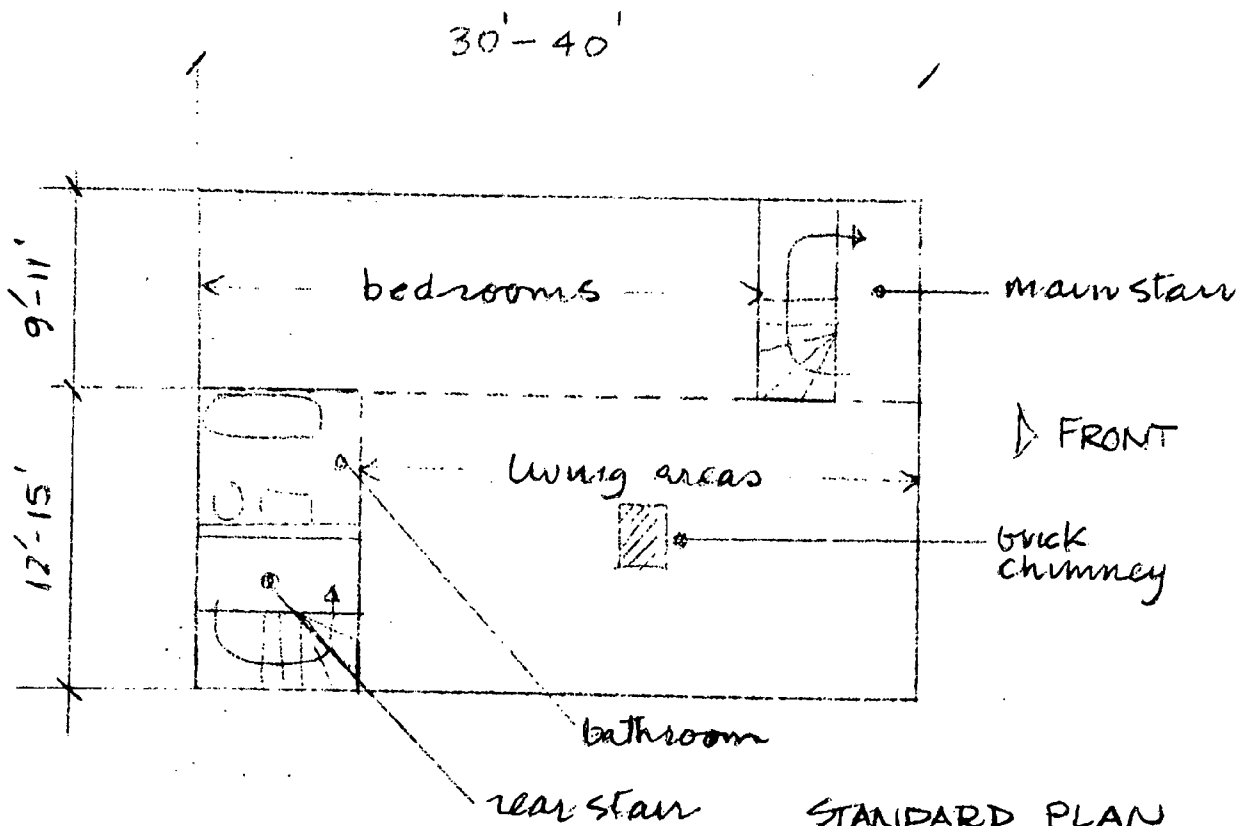
STANDARD PLAN  
DISPOSITION - TWO &  
THREE FAMILY STRUCTURES  
(NOT TO SCALE)

This standard plan arrangement is shown in diagram form on page E-4. The plan is

rectangular, the short sides being the street and rear elevations. The long side elevations usually face the adjacent house across a very narrow side yard. Structurally, the plan divides into two floor spans, the shorter is from 9 to 11 feet, and the larger ranges from 12 to 15 feet. The main staircase is always located on the front wall, within the shorter span. The rear staircase is always in the opposite diagonal corner, located within the larger span. The bathroom is also on the rear wall adjacent to the rear stair and filling the balance of the wider span. The chimney flue is located halfway down the depth of the plan, about the center of the wide span portion. This of course coincides with the partition line between the major rooms (living and kitchen/dining) which fill the wide span section. The bedrooms are located in the narrower span section.

In the examination of the five prototypes, closer scrutiny showed that three of them, though outwardly different, were in fact all variations of the same basic plan arrangement. These three were the three family three-floor structure at 68 Pekin Street, the small two family at 43 Osborn Street, and the larger two family at 34 Hudson Street. As these structures represent common types within central residential areas, this coincidence does suggest that much of the housing under study is susceptible to similar action, and that the field experience gained on the actual treatment of one or two of these structures will have much broader application. In addition, as much of the interior arrangements are standardized, it will be possible to organize a mass treatment program for these structures should this become desirable.

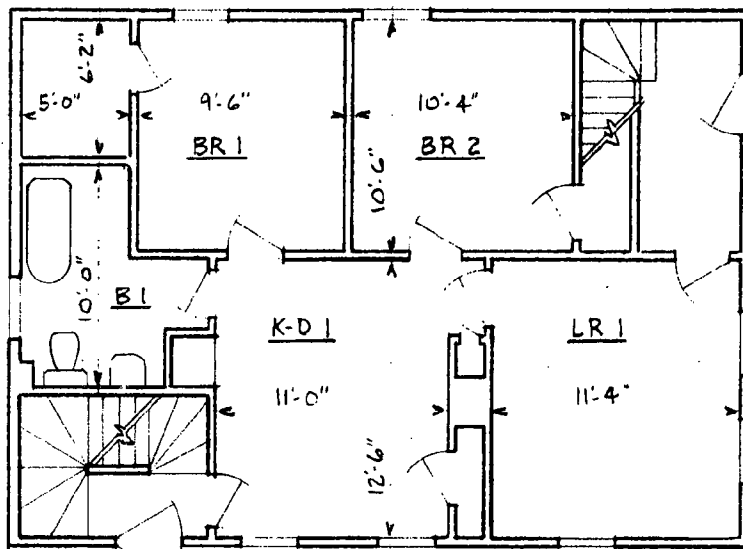
FIRST FLOOR PLAN  
9'-0" CEILING

ROOM	SQ' AREA	FHA REQ
B1	NA	OK
BR 1	100	100
BR 2	108	100
K-D 1	137	100
LR 1	141	160

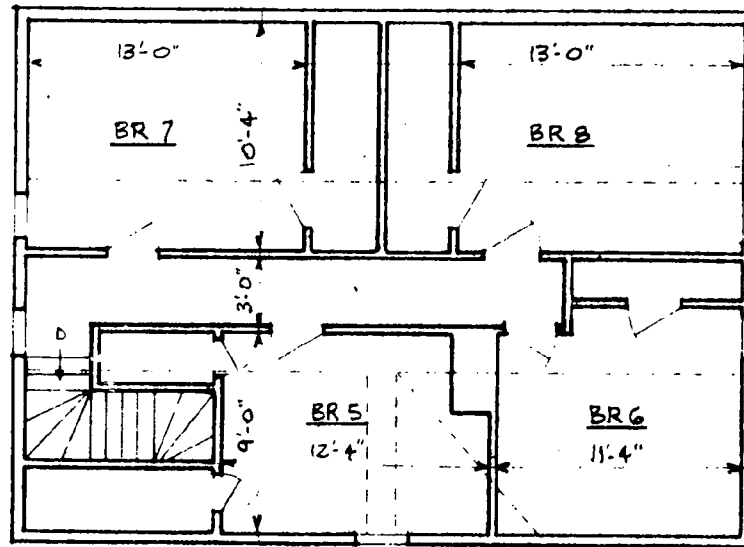
FOURTH FLOOR PLAN  
8'-0" CEILING

ROOM	SQ' AREA	FHA REQ
B 2	NA	OK
K-D 2	129	100
LR 2	142	160
BR 3	131	100
BR 4	105	100
BR 5	91.5*	100†
BR 6	80*	80†
BR 7	33.8*	100†
BR 8	33.8*	100†

\* AREA CALCULATED AS  
TWICE THAT WITH AT LEAST  
7'-6" CEILING HEIGHT

† AREAS CALCULATED  
ASSUMING USE AS FOUR  
BEDROOM APARTMENT

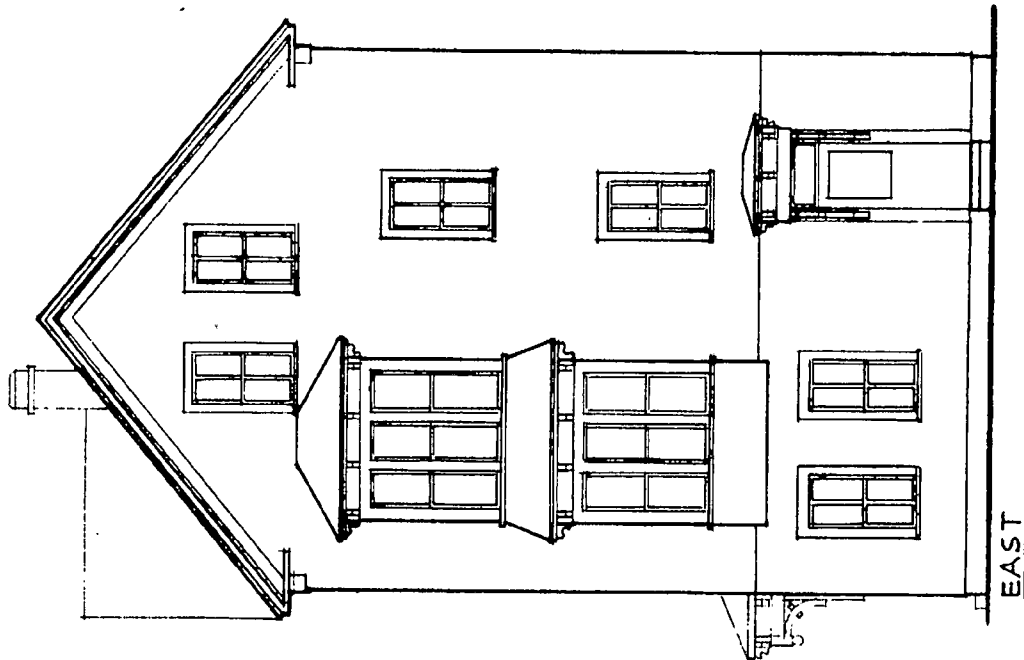
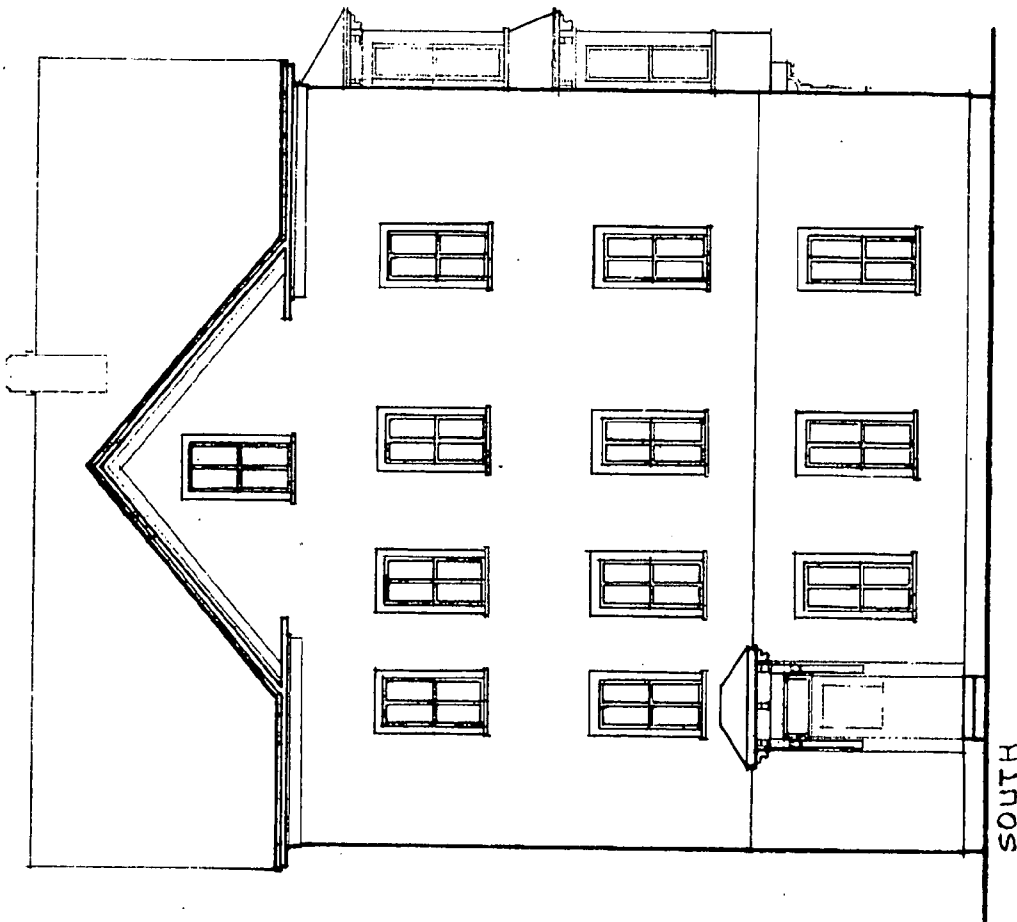
SCALE  $\frac{1}{8}" = 1'-0"$   
Exhibit 1-A

68 PEKIN STREET

- A: Floor plan and elevations of the existing structure.
- B: Analysis of the work required for improvement to stages one and two, and the estimated costs of this work.
- C: Analysis of the work required for improvement to stages three and four, and the estimated costs of this work.
- D: Floor plans illustrating improvement to stage three.
- E: Floor plans illustrating improvement to stage four.

Exhibit 1: A three family wood frame structure at 68 Pekin Street.

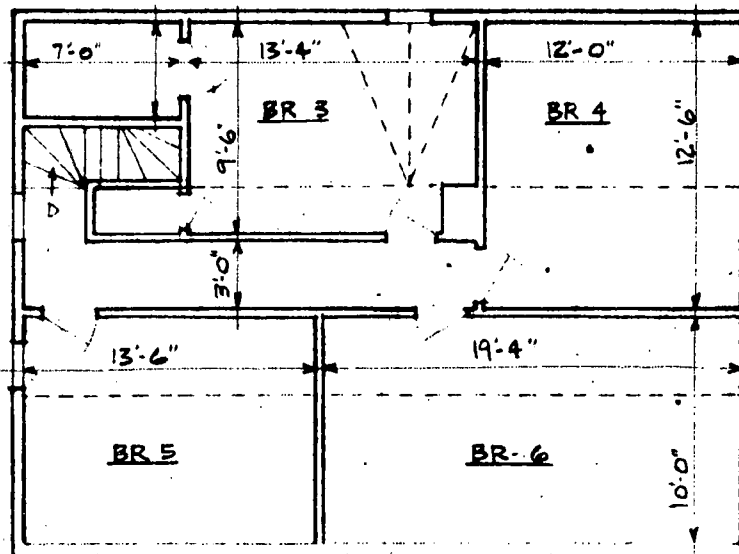
THIRD FLOOR PLAN  
7'-10" CEILING

ROOM	SQ' AREA	FHA REQ
K-D	155	100
L.R.	177	160
B	NA	OK
BR 1	105	100
BR 2	103	100
BR 3	57.5 *	MIN 80 †
BR 4	142 *	100 †
BR 5	108 *	100 †
BR 6	154 *	100 †

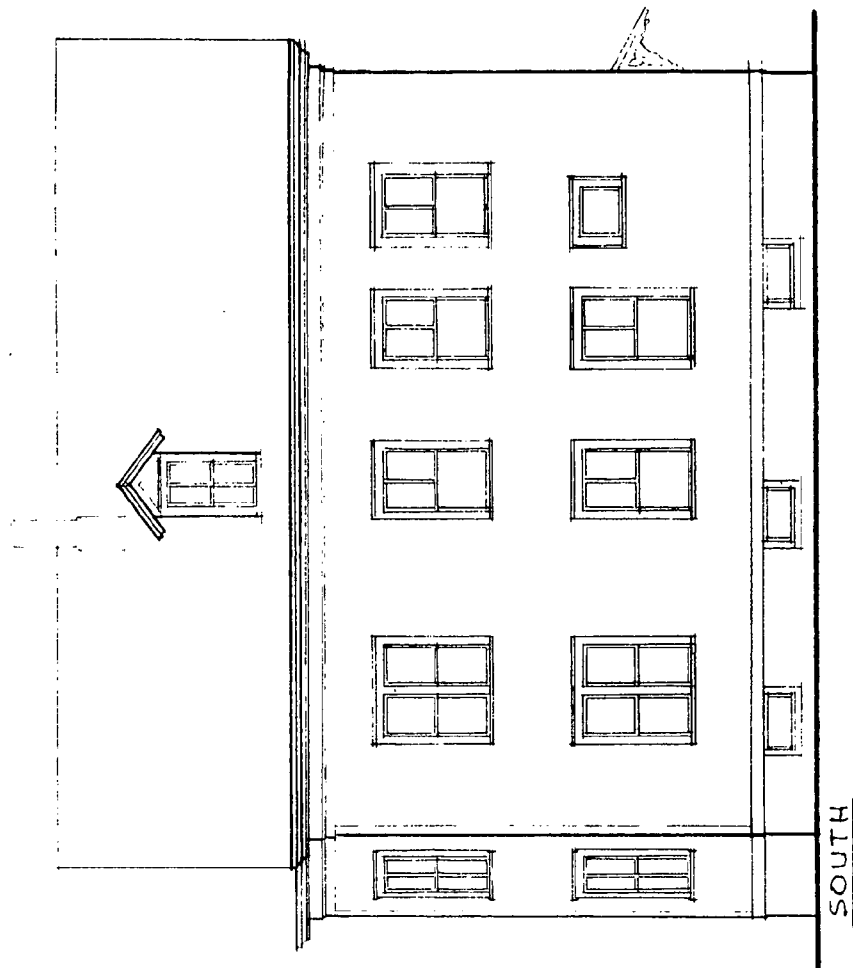
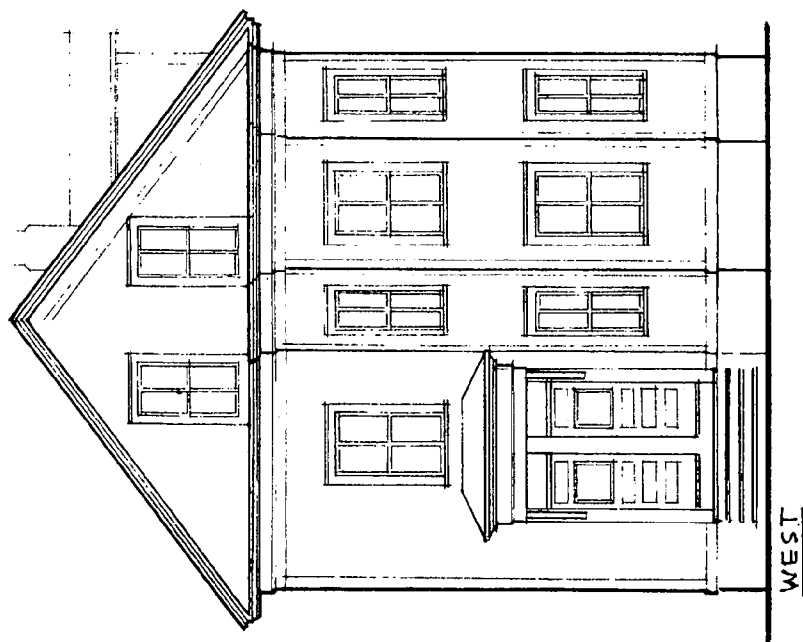
SCALE  $\frac{1}{8}" = 1'-0"$   
Exhibit 2-A

43 OSBORN STREET

Exhibit 2: A two family wood frame structure at 43-45 Osborn Street.

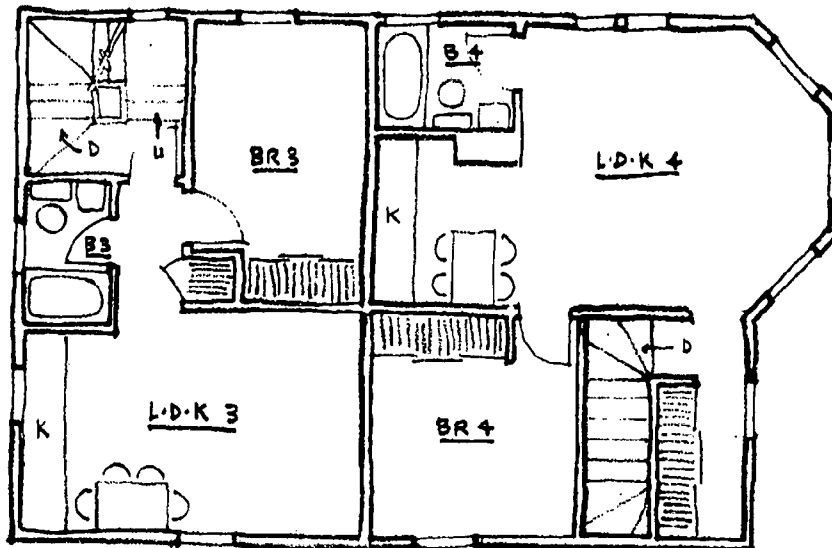
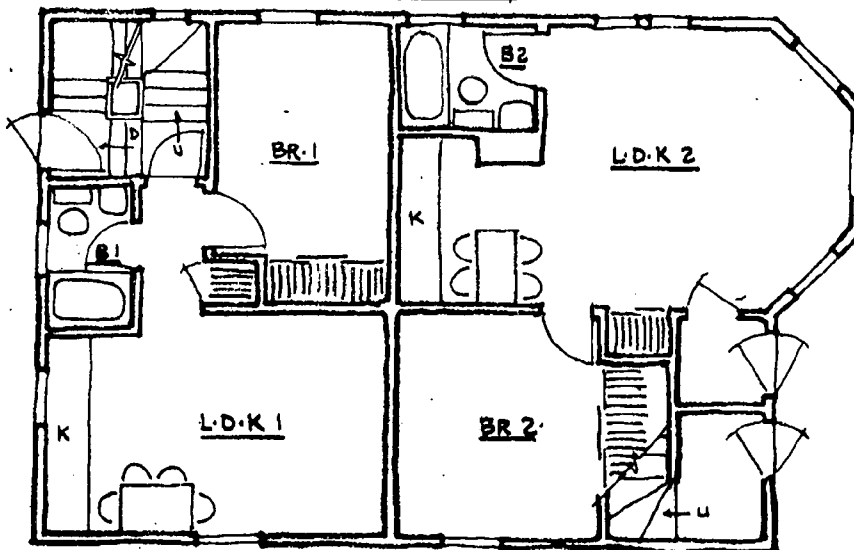
SCALE 1/8" = 1'-0"  
Exhibit 2-D

THIRD FLOOR UNCHANGED  
USED AS STORAGE...

43 OSBORN ST

4-1 BR APTS USING EXISTING STACKS WHERE POSS.

Estimated costs of repairs per plans submitted. Conversion of this house from 2 family to 4 family. The original costs submitted will apply plus the listed changes.

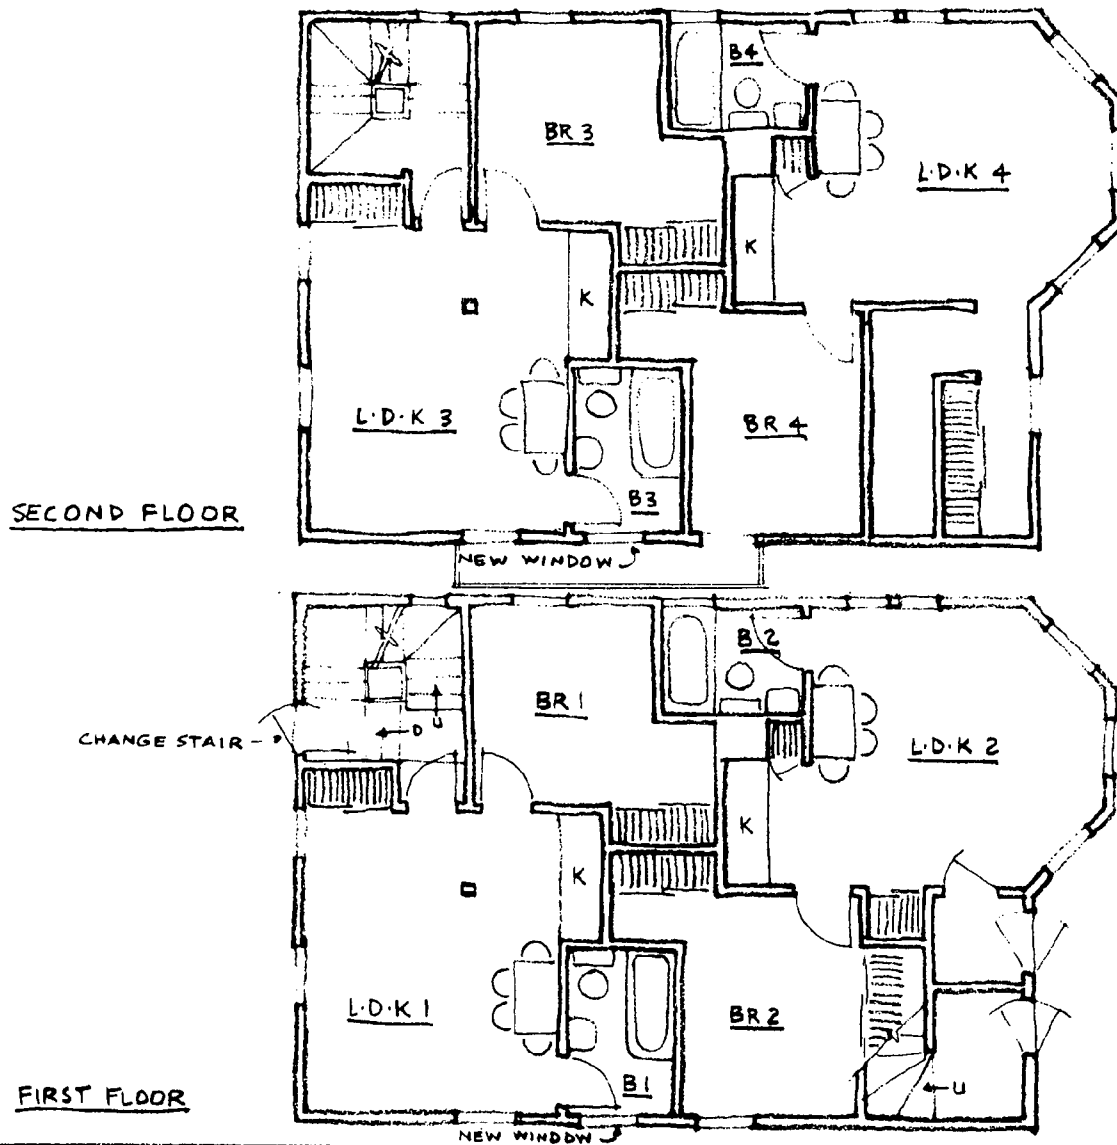
THIRD FLOOR UNCHANGED -  
USED AS STORAGE .....

43 OSBORN ST

4-1 BR APT WITH UTILITY CORE IN CENTER OF STRUCTURE

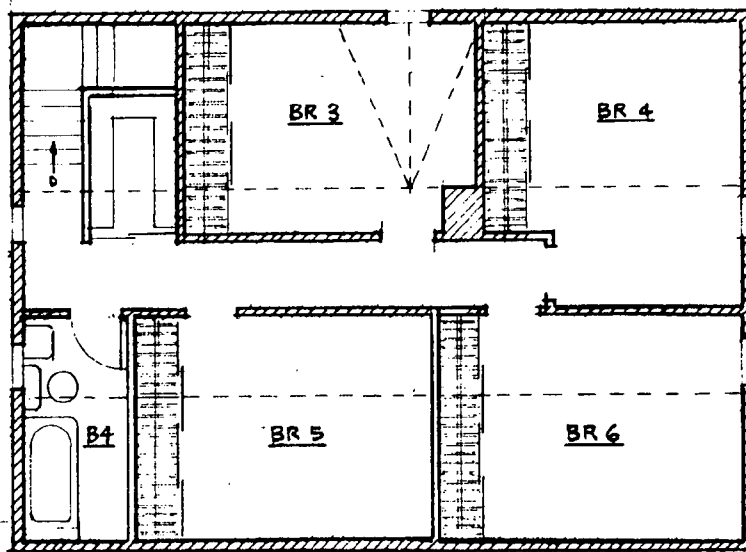
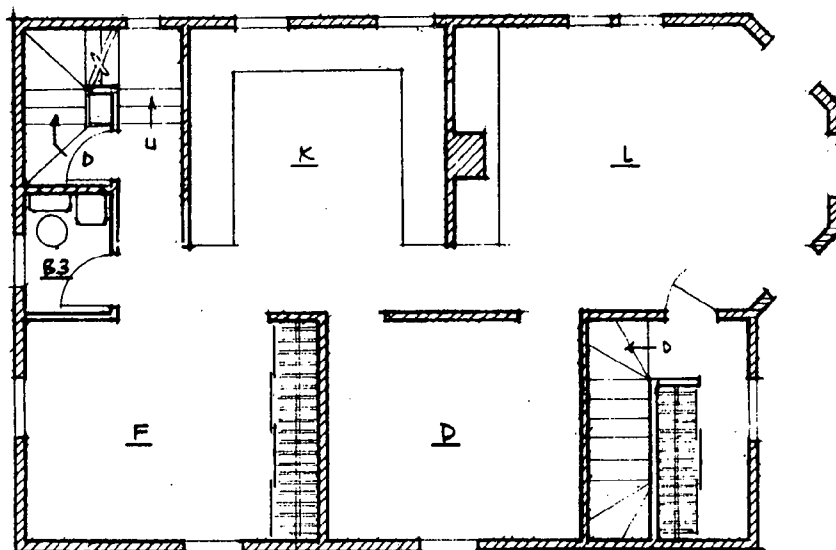
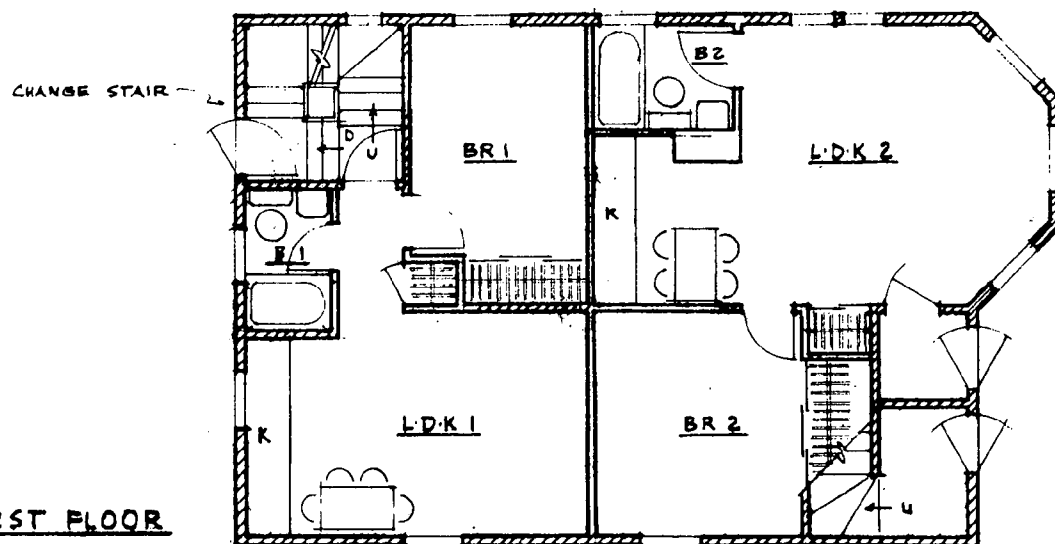
SCALE 1/8" = 1'-0"  
Exhibit 2-E

43 OSBORN STREET

2-1 BR APTS 1ST FL, 1 FAMILY ABOVE  
USING EXISTING STACKS WHERE POSSIBLE

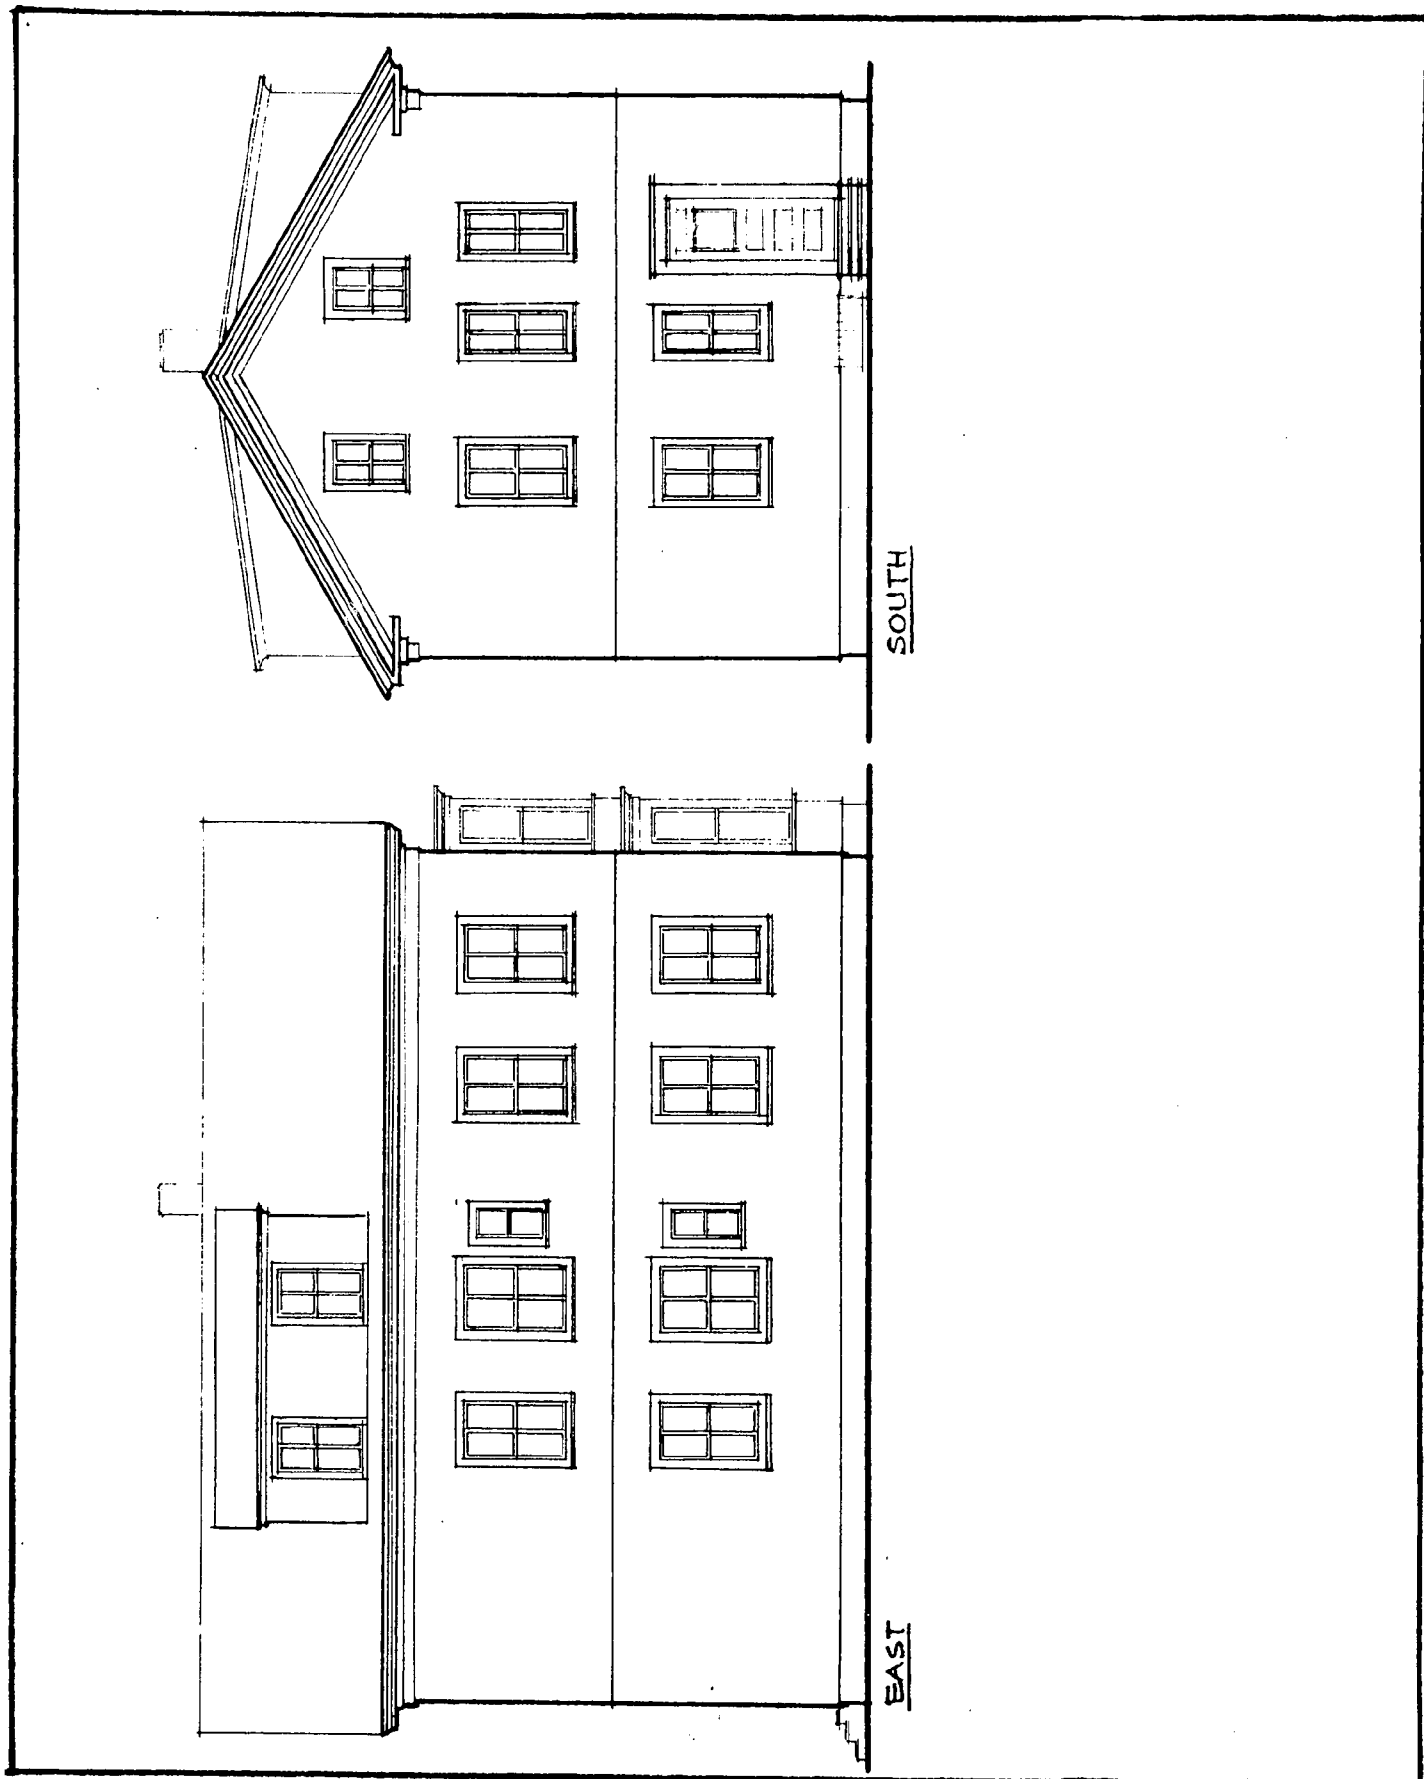
34 HUDSON STREET

Exhibit 3: A three family wood frame structure at 34 Hudson Street.

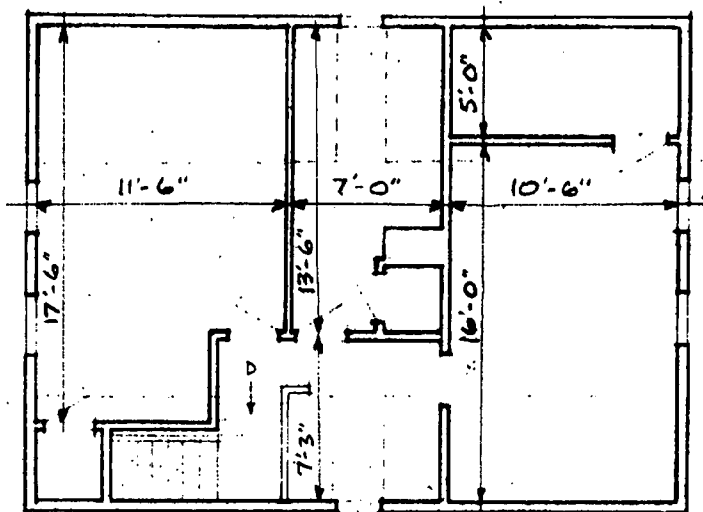
SECOND FLOOR PLAN  
7'-10" CEILING

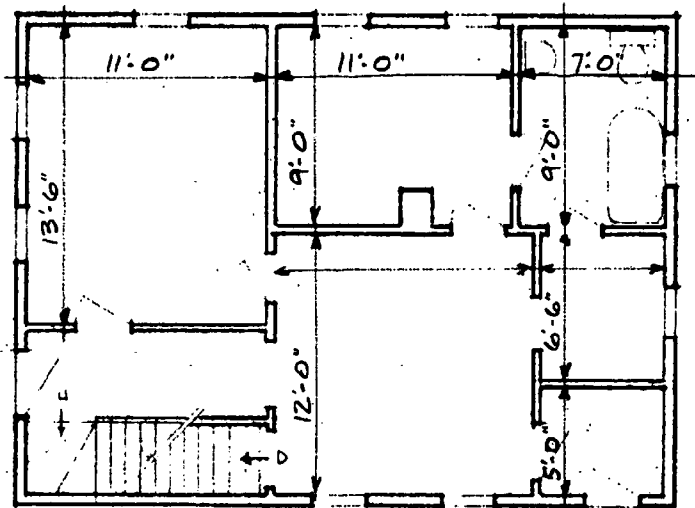
FIRST FLOOR PLAN  
7'-10" CEILING

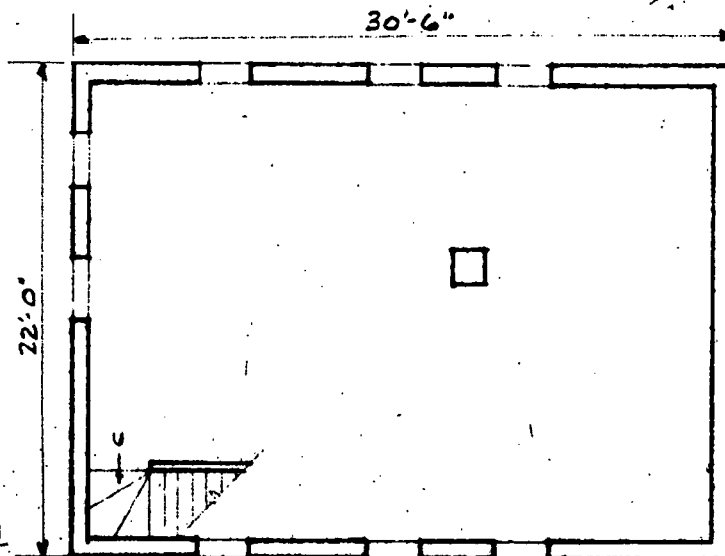
BASEMENT PLAN  
7'-0" CEILING

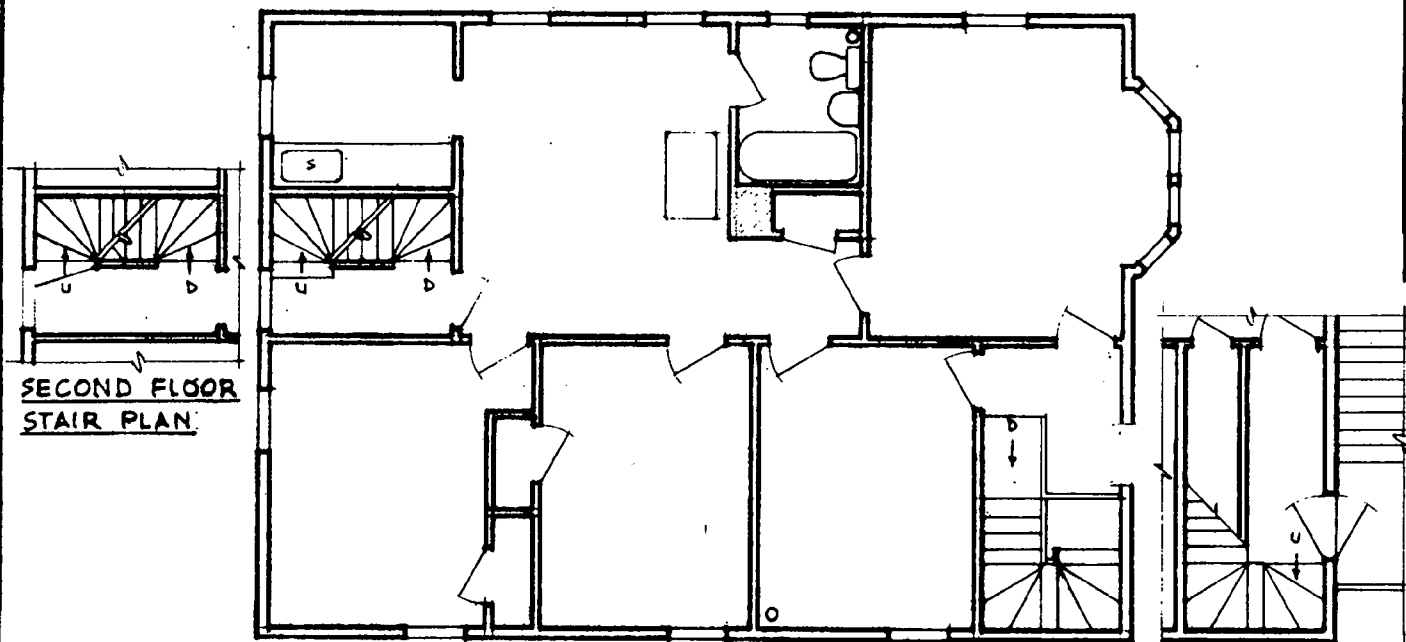
FIRST FLOOR PLAN

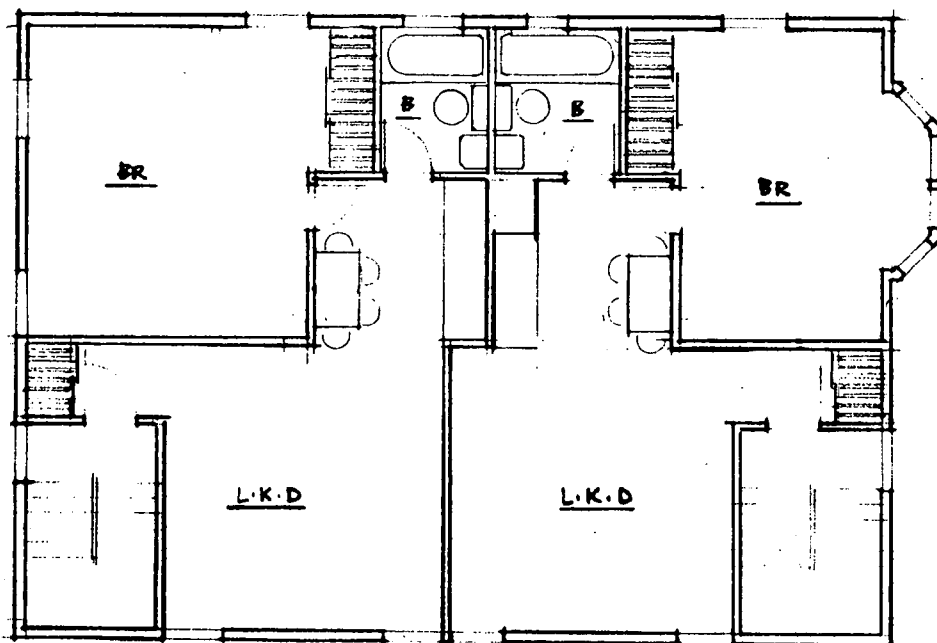
SCALE 1/8" = 1'-0"  
Exhibit 5-D

FIRST FLOOR USED AS  
PARKING FOR 4 CARS..

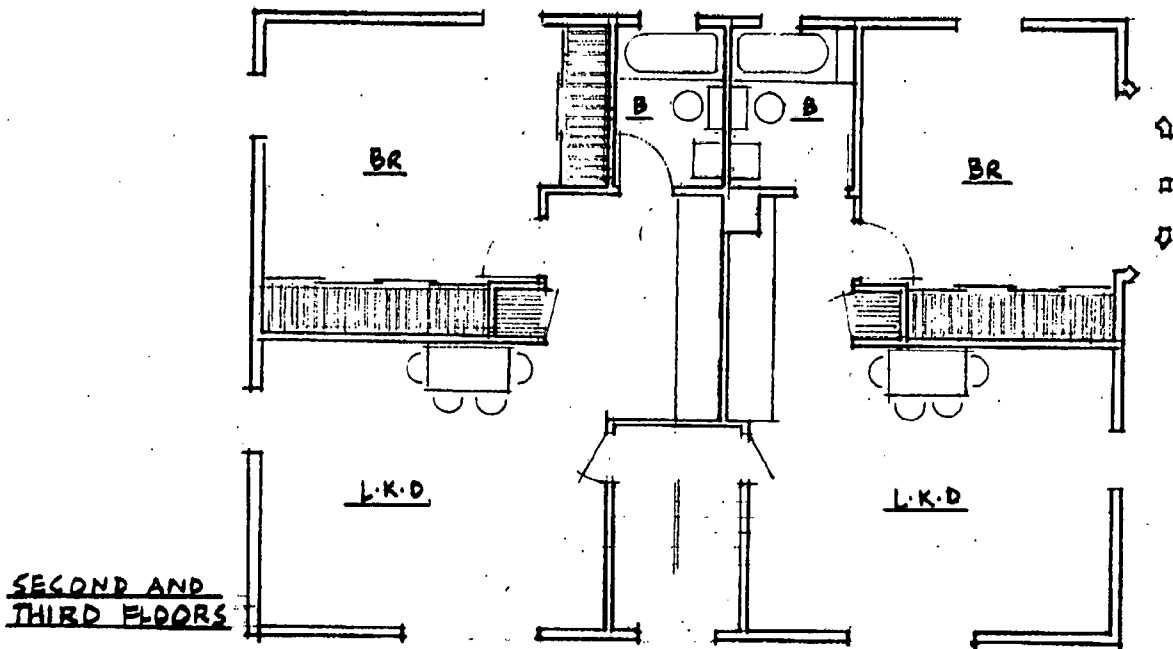
SCALE 1/8" = 1'-0"  
Exhibit 5-D

111 KNIGHT ST  
SCHEME 2

FIRST FLOOR USED AS  
PARKING FOR 4 CARS ..

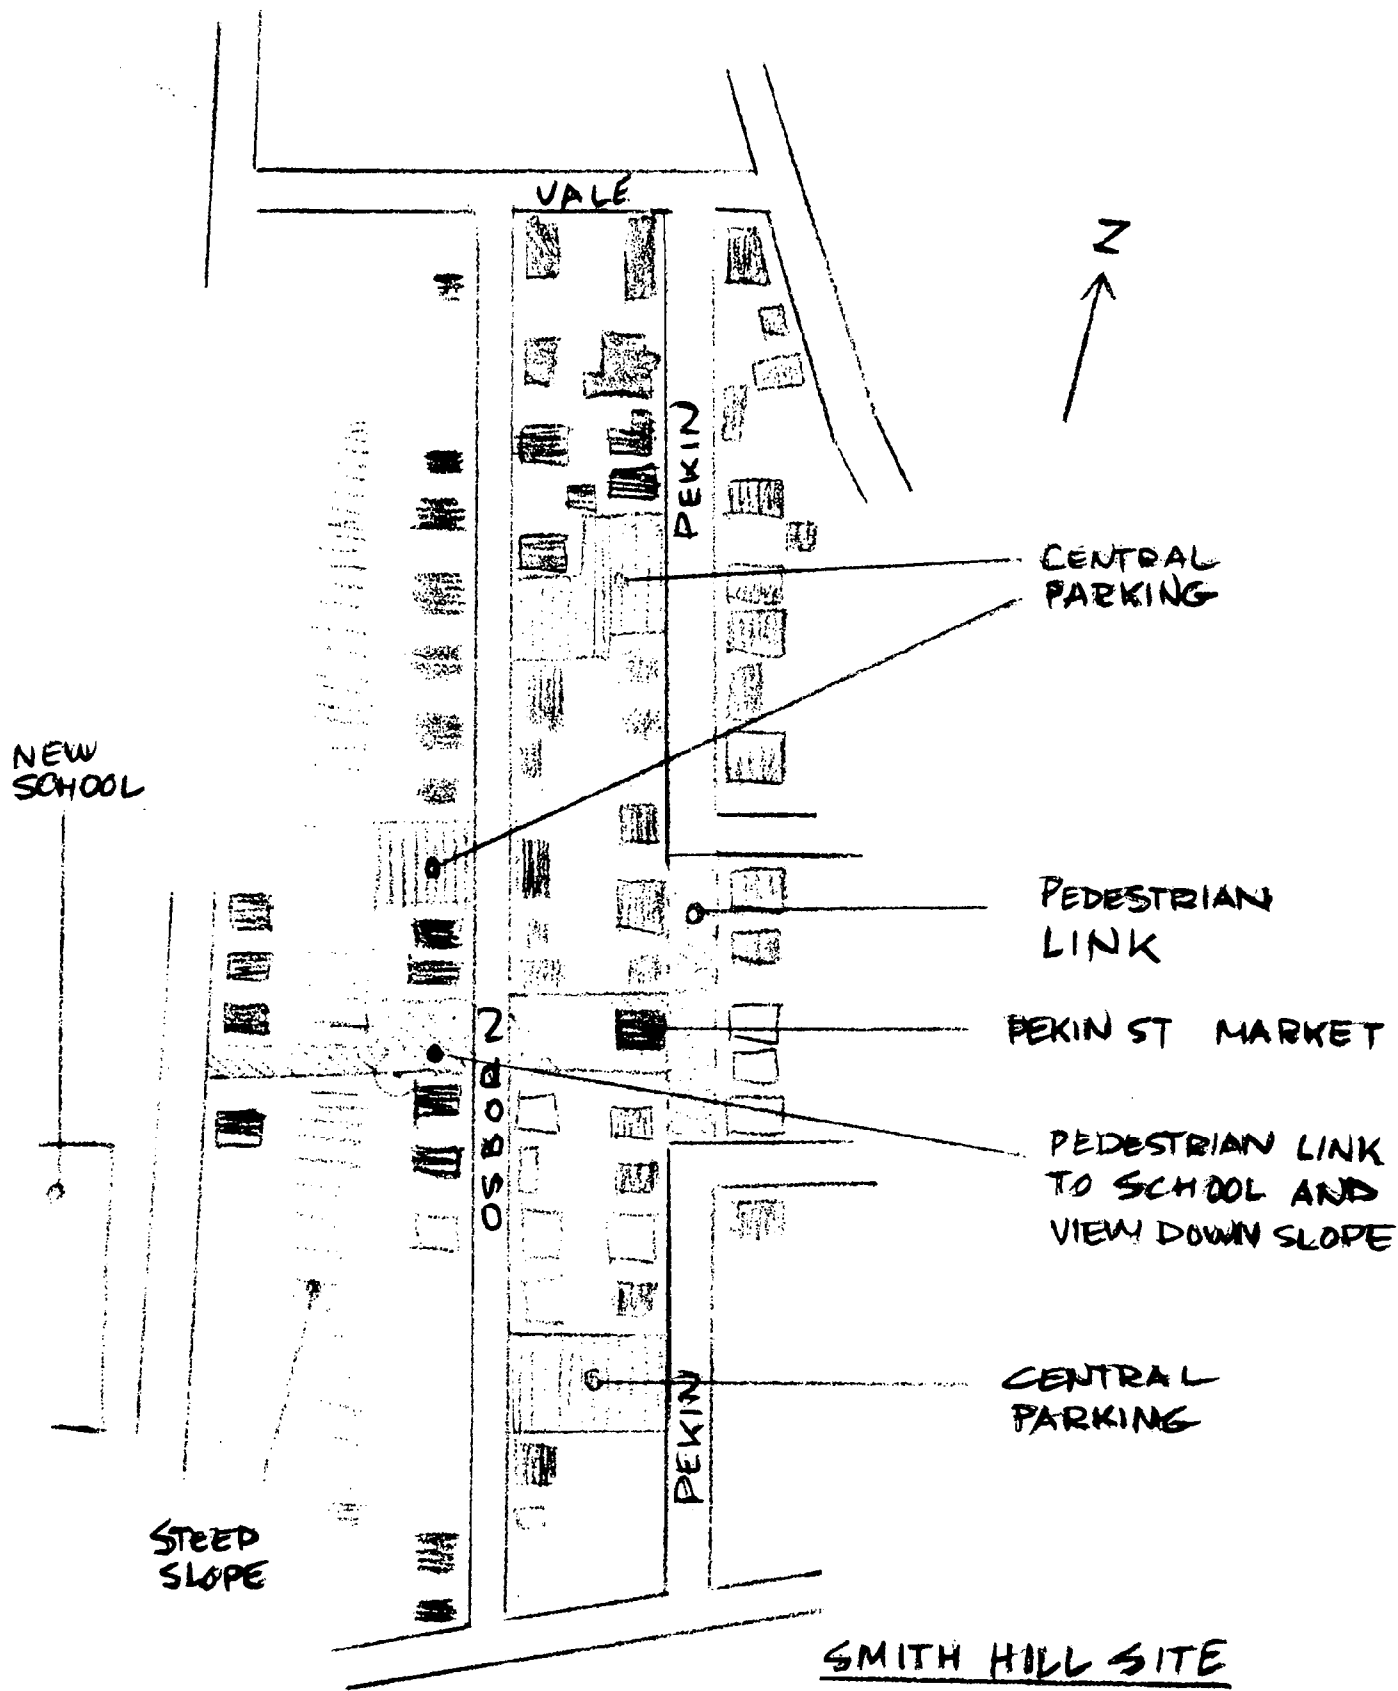
SMITH HILL SITE

PEKIN ST E OSBORN ST

RECOMMENDED BLOCK TREATMENT  
 DIAGRAMMATIC - NOT TO SCALE

This sample block is composed entirely of two and three family structures on two or three floors. The streets are long and narrow with about 35 feet between building frontages and front yards are minute. The length of the street is exaggerated by this proportion of width to building height, and as they terminate in streets of similar scale and character, the block is visually disconnected from any community or topographical

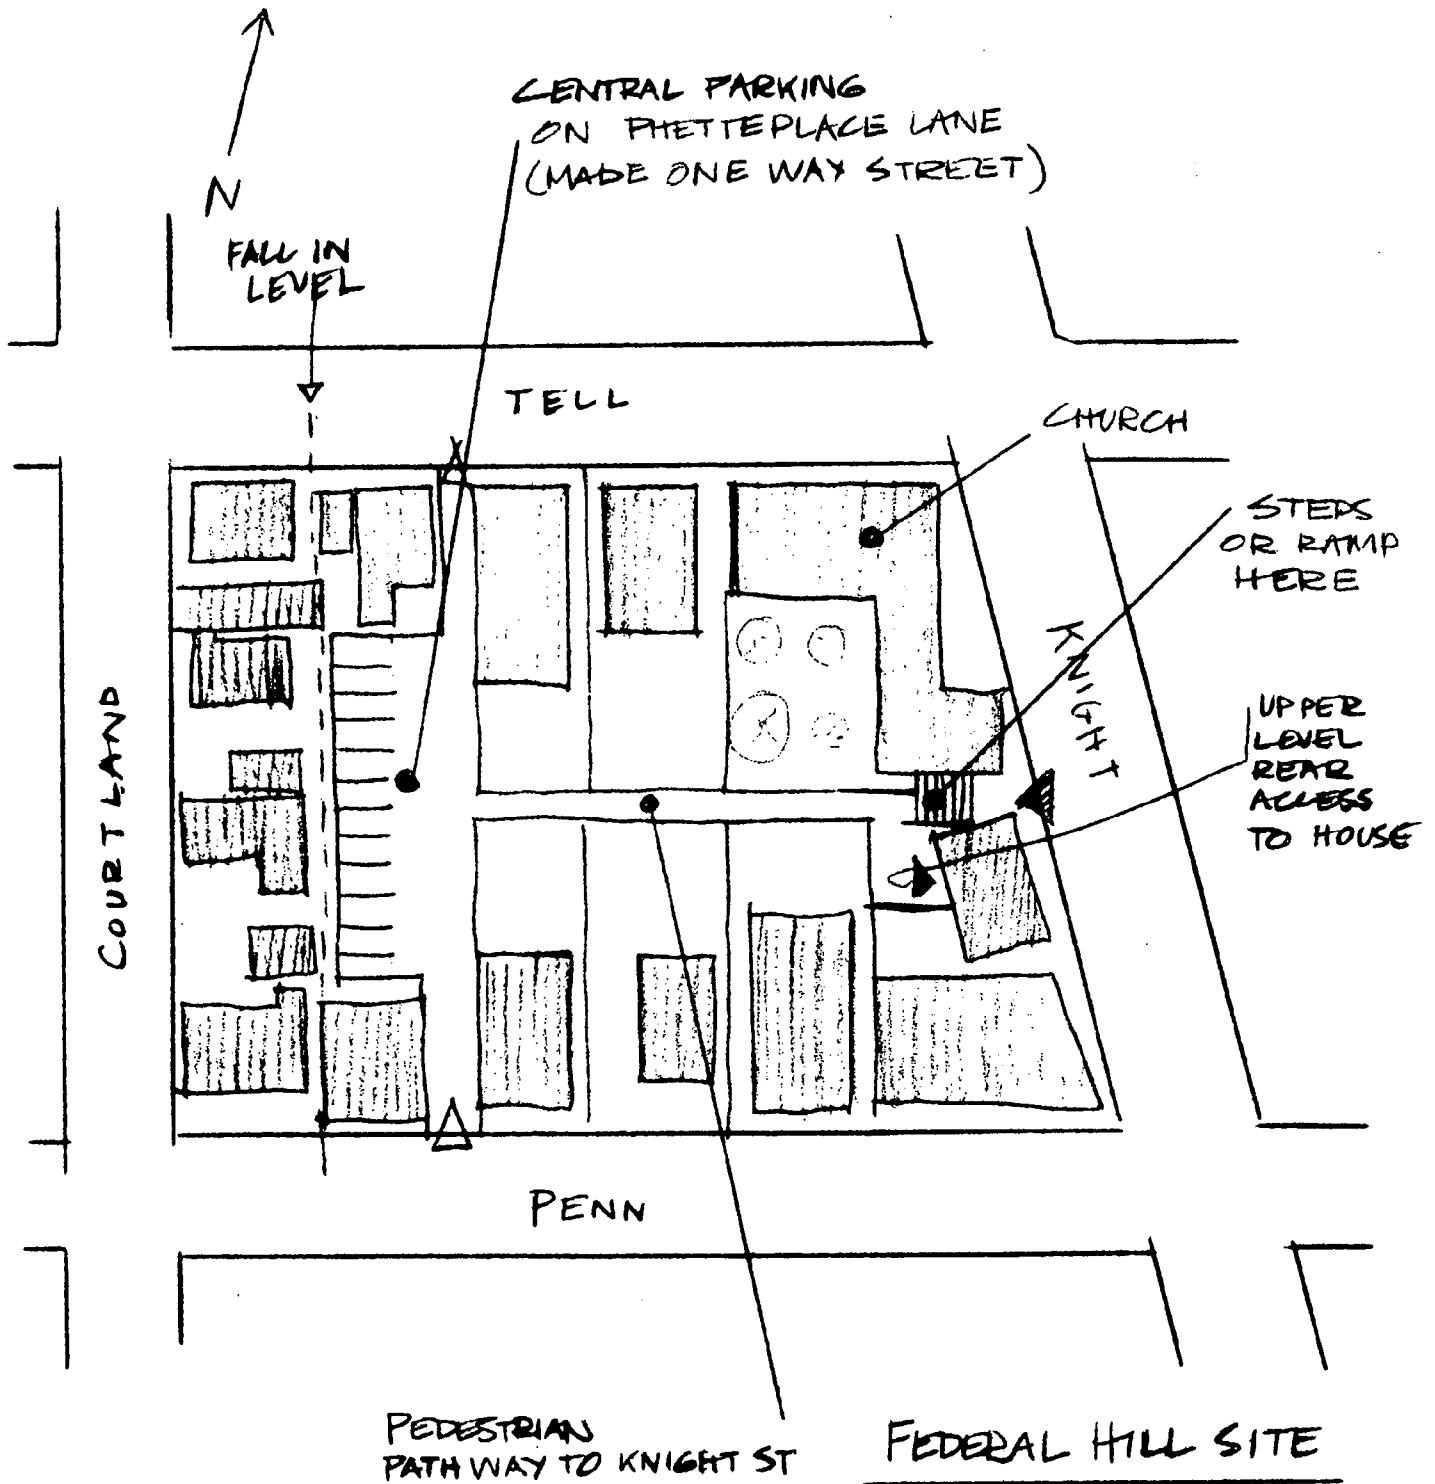
FEDERAL HILL SITE  
~~RECOMMENDED~~ BLOCK  
TREATMENT.

DIAGRAMMATIC - NOT TO SCALE.

In form, this block is very compact and small, though made up of the greatest variety of different uses and structures, including stores and churches. Knight Street is the busiest frontage on the block. Road access is available to the center of the block, and access to the structures through the back yards is possible on all sides except to the housing on Courtland Street where a ten foot drop in ground level prevents this. This barrier means all access to these houses comes off Courtland Street and the social orientation of them is away from the central back yard space which is the natural focus of the other housing.

Block treatment here should be mainly a matter of tidying up these existing arrangements. The parking now spread over the western side of the block could be consolidated as a strip on the west side of Phetteplace Lane. By making a pedestrian pathway down the center of the interior space on the rear lot lines to connect Phetteplace Lane through to

In instances where parking areas are actually part of the street, such as in the Federal Hill site, ownership and maintenance by the city may be more feasible. The estimated cost of constructing such a facility excluding the cost of the land is:
