**PROVIDENCE  
COMMUNITY  
RENEWAL  
PROGRAM  
1964 - 1970**

**TECHNICAL SUPPLEMENT**

**APPENDIX D·E·F·G**

**BLAIR ASSOCIATES • PLANNERS • PROVIDENCE • RHODE ISLAND**

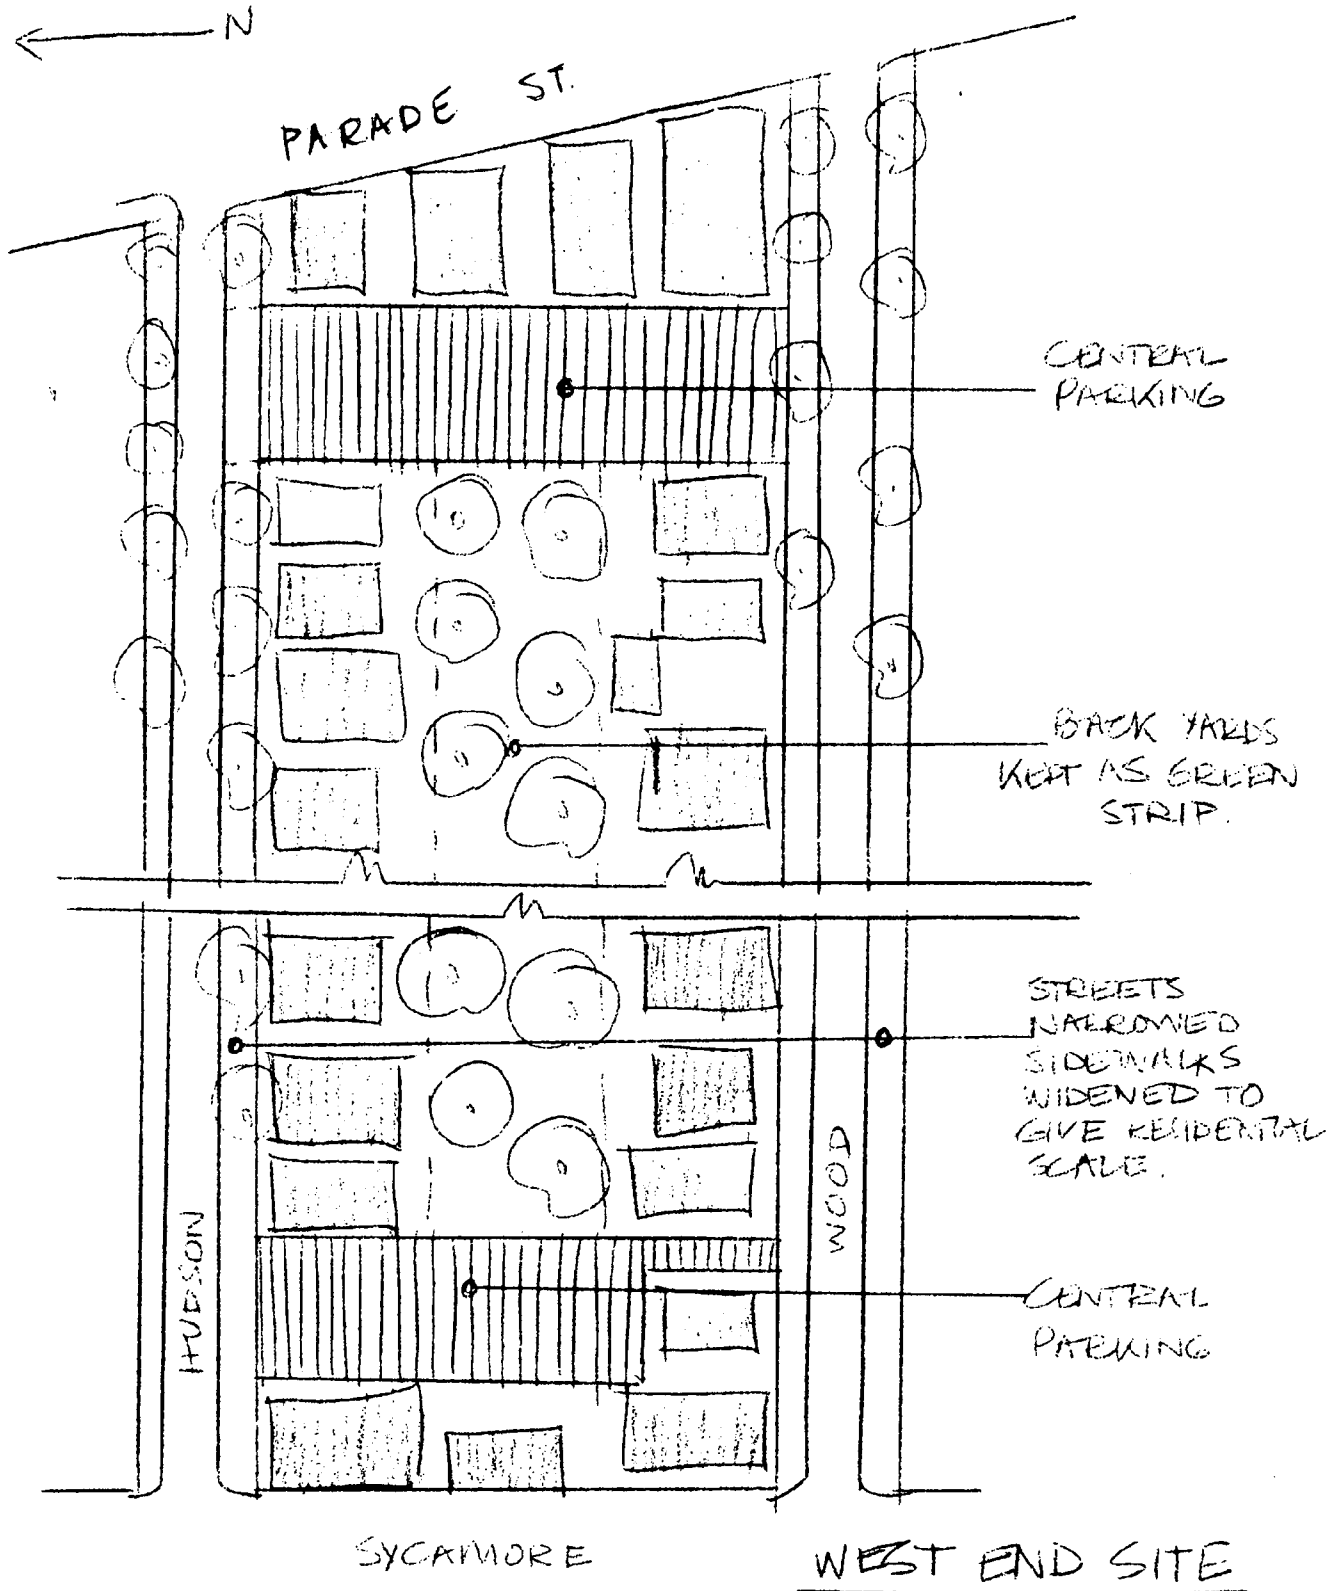
RECOMMENDED BLOCK TREATMENT  
 DIAGRAMMATIC-NOT TO SCALE

In this block, there is a noticeable deterioration of structure and upkeep as one proceeds away from the Parade Street end. The housing at Sycamore Street exhibits incipient blight, which can probably be remedied by individual rehabilitation, but which is also indicative of a larger scale condition which probably needs a more fundamental solution. The introduction of the parking area here will make a strong separation between the Sycamore Street houses and the rest of the block. Another proposal (and one made without knowledge of the traffic patterns around the block, nor the location and accessibility of the under road services) is to break the visual continuity of the roads from this block to the blocks to the west, by narrowing down the roadways on both Hudson and Wood streets to a minimum two car width, and then use the fifteen feet or so which is gained either as grass strips, or better as extensions of the present rather skimpy front yards which would then be the maintenance responsibility of the individual owners. By this treatment what is now in the scale and appearance of a main thoroughfare will be converted into a residential access road of appropriate size and character.

In general, the density and organization of the housing does not need change, though there are one or two instances of loss of amenity through too close siting. Any lot

vacancy caused by demolition is probably best treated by increasing the lots of adjoining owners. If larger open space becomes available, the density should be maintained by building new single family housing.

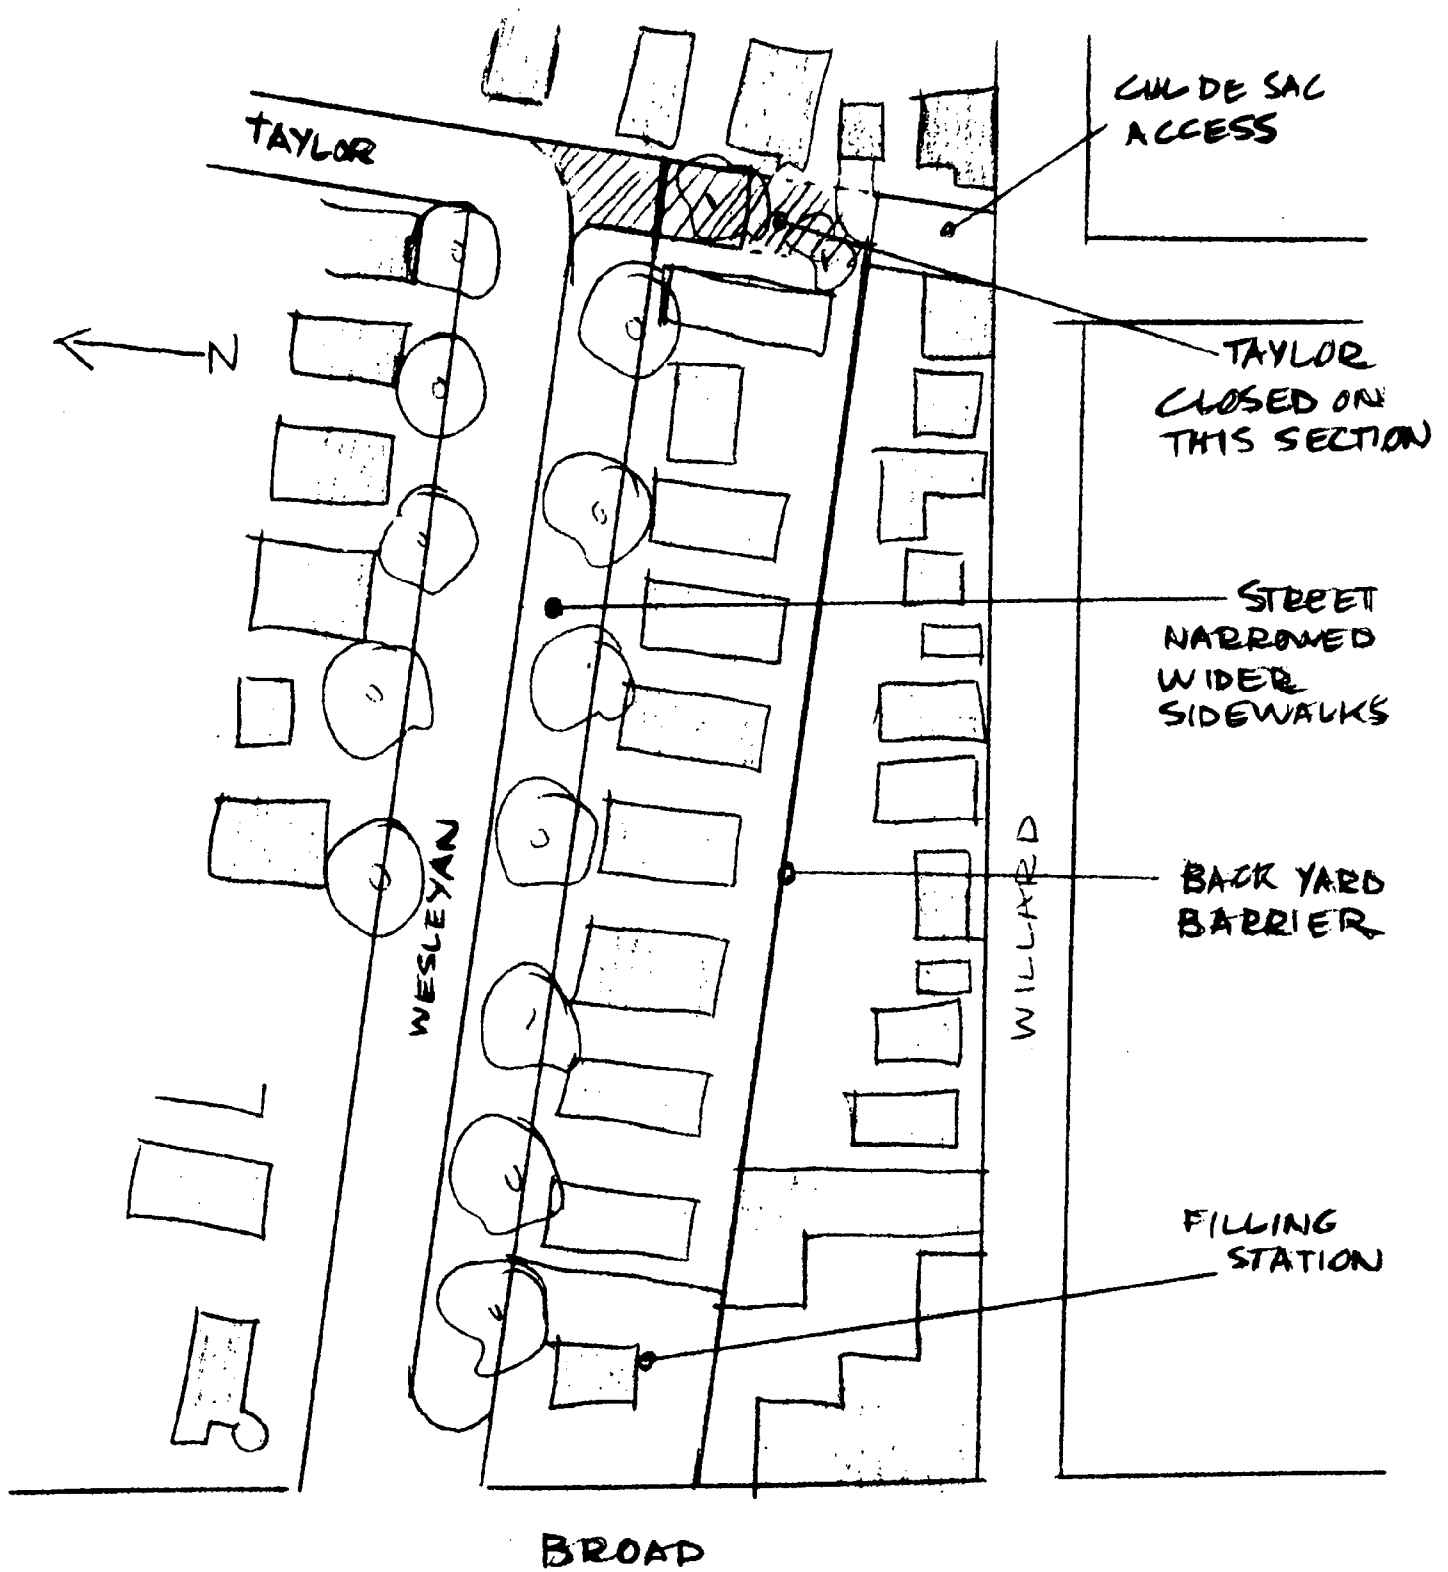
RECOMMENDED  
BLOCK  
TREATMENT

UPPER SOUTH PROVIDENCE SITE  
DIAGRAMMATIC - NOT TO SCALE

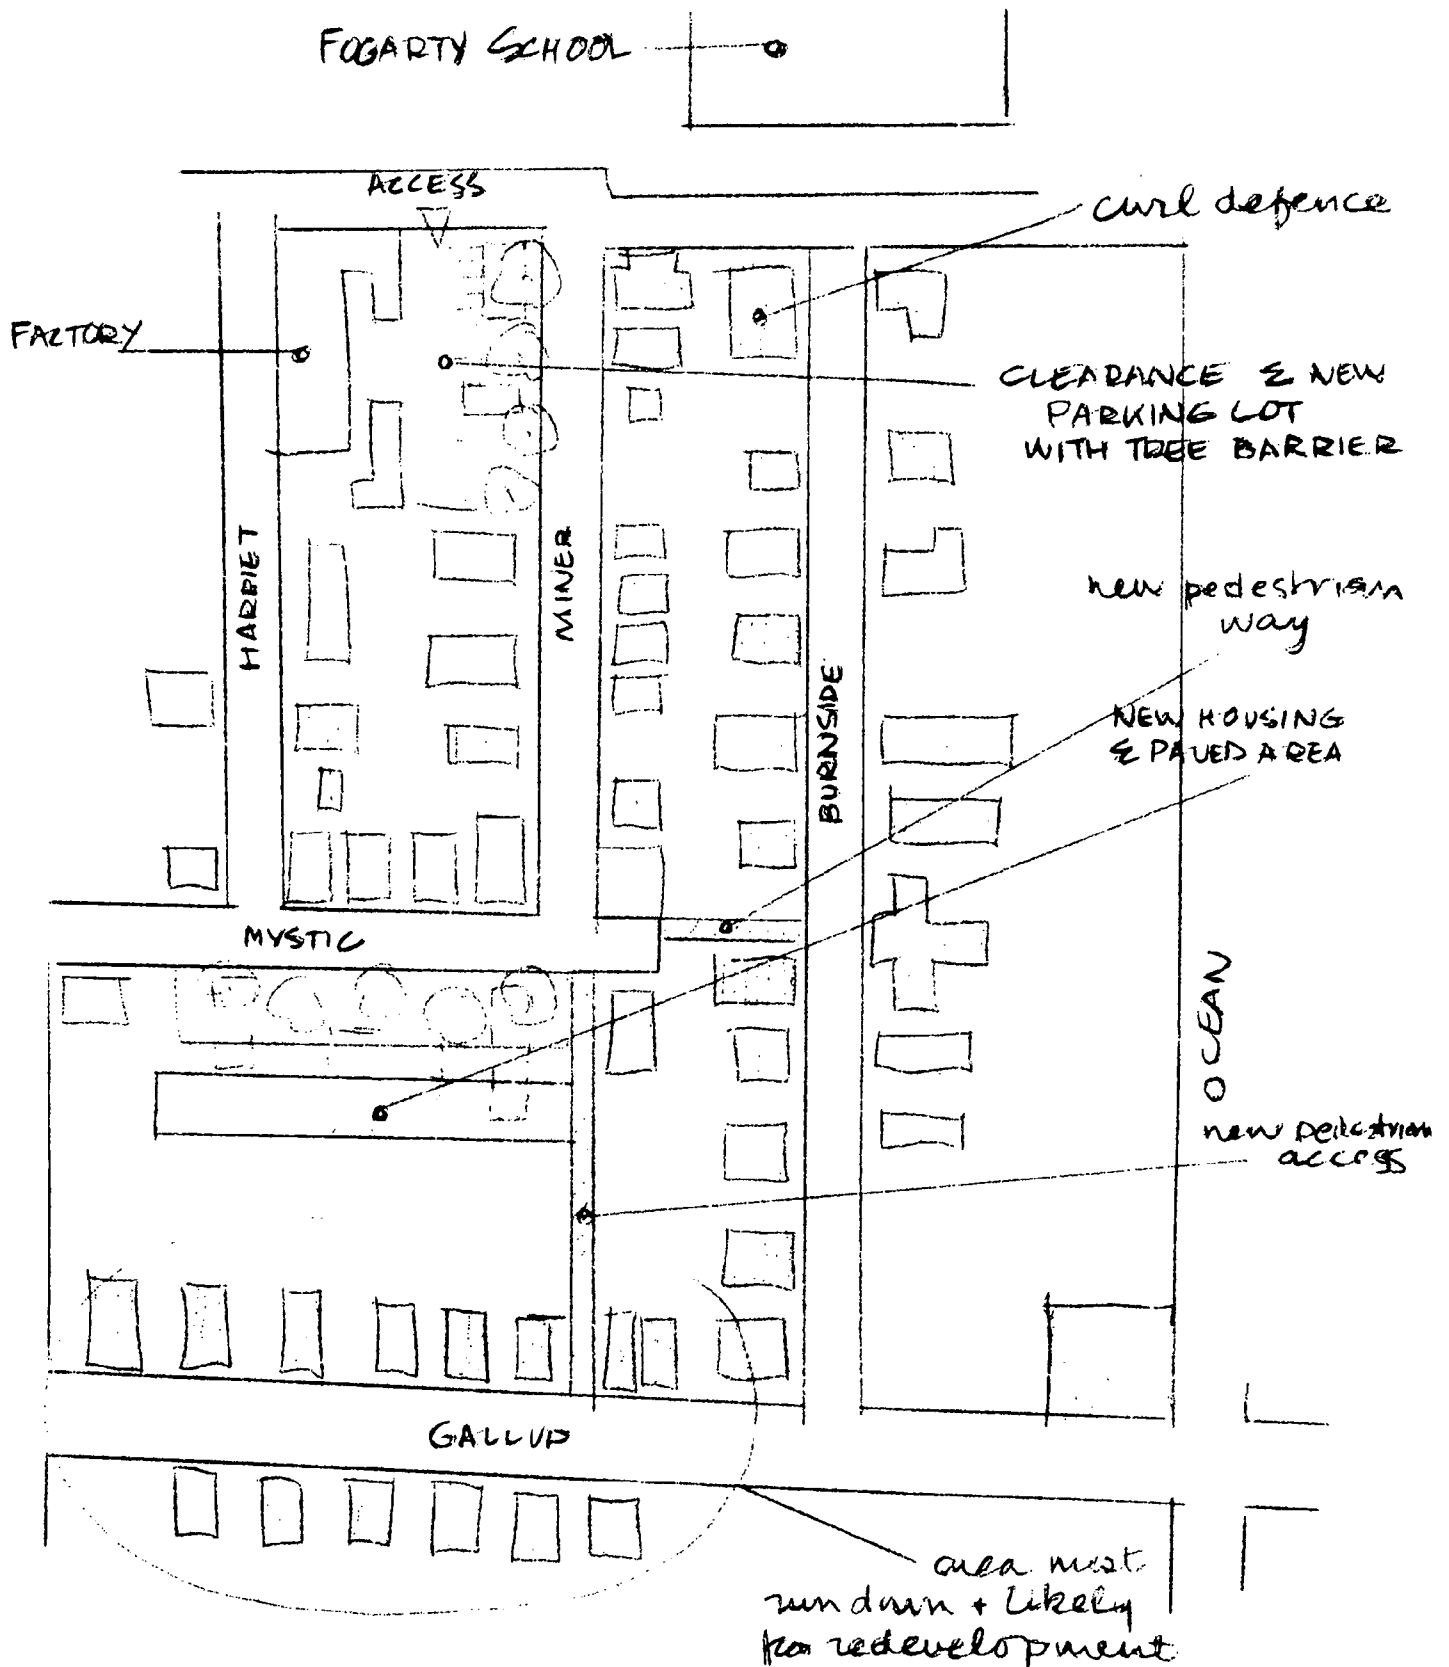
LOWER SOUTH PROVIDENCE SITE  
 DIAGRAMMATIC - NOT TO SCALE

This area contrasts with the other sites by having considerably lower density and generally smaller scale housing. The main impression of the area is of diffuseness, and lack of community adhesion, as though it is overflow housing from somewhere else. In some ways, this atmosphere is generated by the lower densities and undeveloped open spaces, but the solution does not necessarily lie in increasing the density by filling the open lots with houses. Though a more definite "center of gravity" or nucleus to the block is necessary, and probably needs some building up adjacent to the junction of Miner and Mystic Streets, other open spaces should be left as such, but given some function that becomes a positive factor in the total environment, and no longer appears derelict or unused. One such space occurs at the rear of the wood working factory. Here the two nearest houses on Miner Street show pronounced dilapidation, perhaps due to their proximity to the plant. There are two possibilities open; one to relocate the plant, and the other to create around it a more effective separation of residential and industrial uses.
